MVS
ENGINEERING PVT. LTD.

Service Bulletin

S1014

PERCENTAGE ANALYZER SENSOR REPLACEMENT PROCEDURE

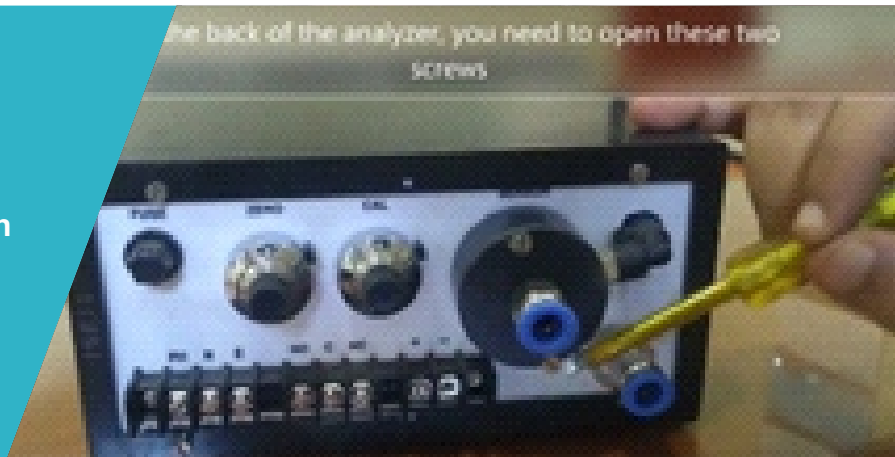
On the back of analyzer, you need to open two screws

- Using a screwdriver, open the screw and remove them by hand
